Biological Report

Lake Shastina Community Services
Infrastructure Improvement Project
Lake Shastina, California

February 2023

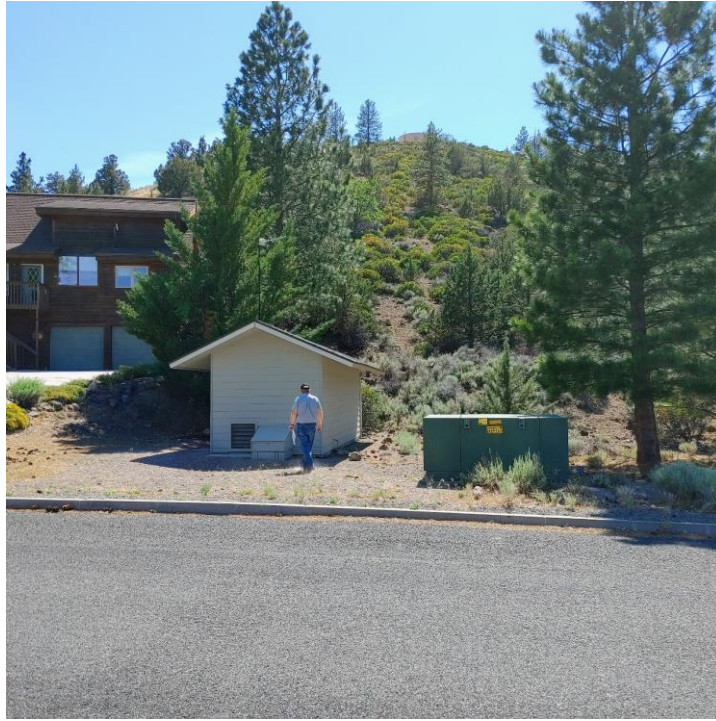
Photo 1: Looking west at pump station 53 on Palmer Drive where the location of the temporary water tank outside of the building would be placed as water tank 4 is upgraded to a bigger size. Water tank #4 can be seen on top of the slope. Gravel is observed on the east side of the pump station where the temporary water tank would be placed. Photo taken: 6/22/2022.

- Place a temporary water tank outside of pump station 53 on APN: 107-080-270-000, LSCSD owned, legal description: Unit 5 Lots 8 & 9 One OR 98 9949 Lake Shastina. See Appendix 1, Photo 1 and Figure 2.

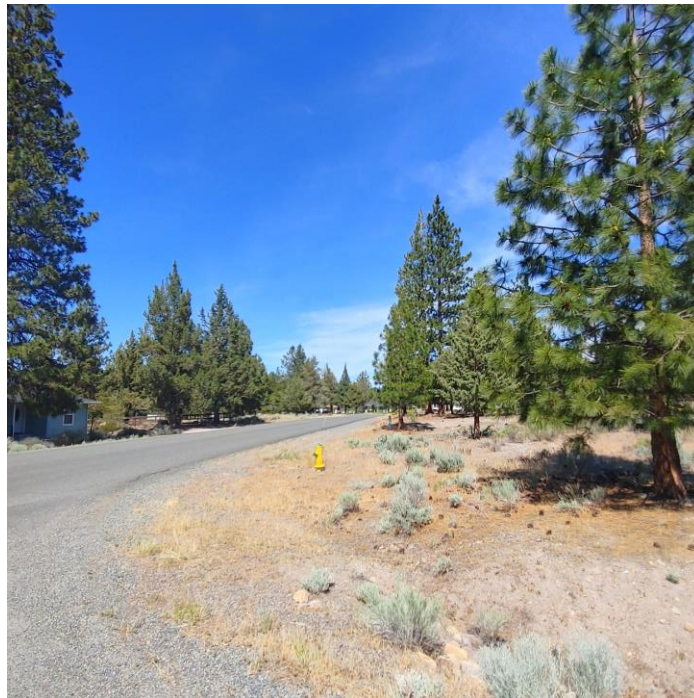
Photo 2: Looking east at the location of the new pump station on Elk Trail Road and Hogan Drive by fire hydrant #191. Small sized rabbit brush, small rocks and cheat grass is observed as vegetation that would be disturbed. The ponderosa pines in the picture were observed for nests and zero were found. Photo taken: 6/22/2022.

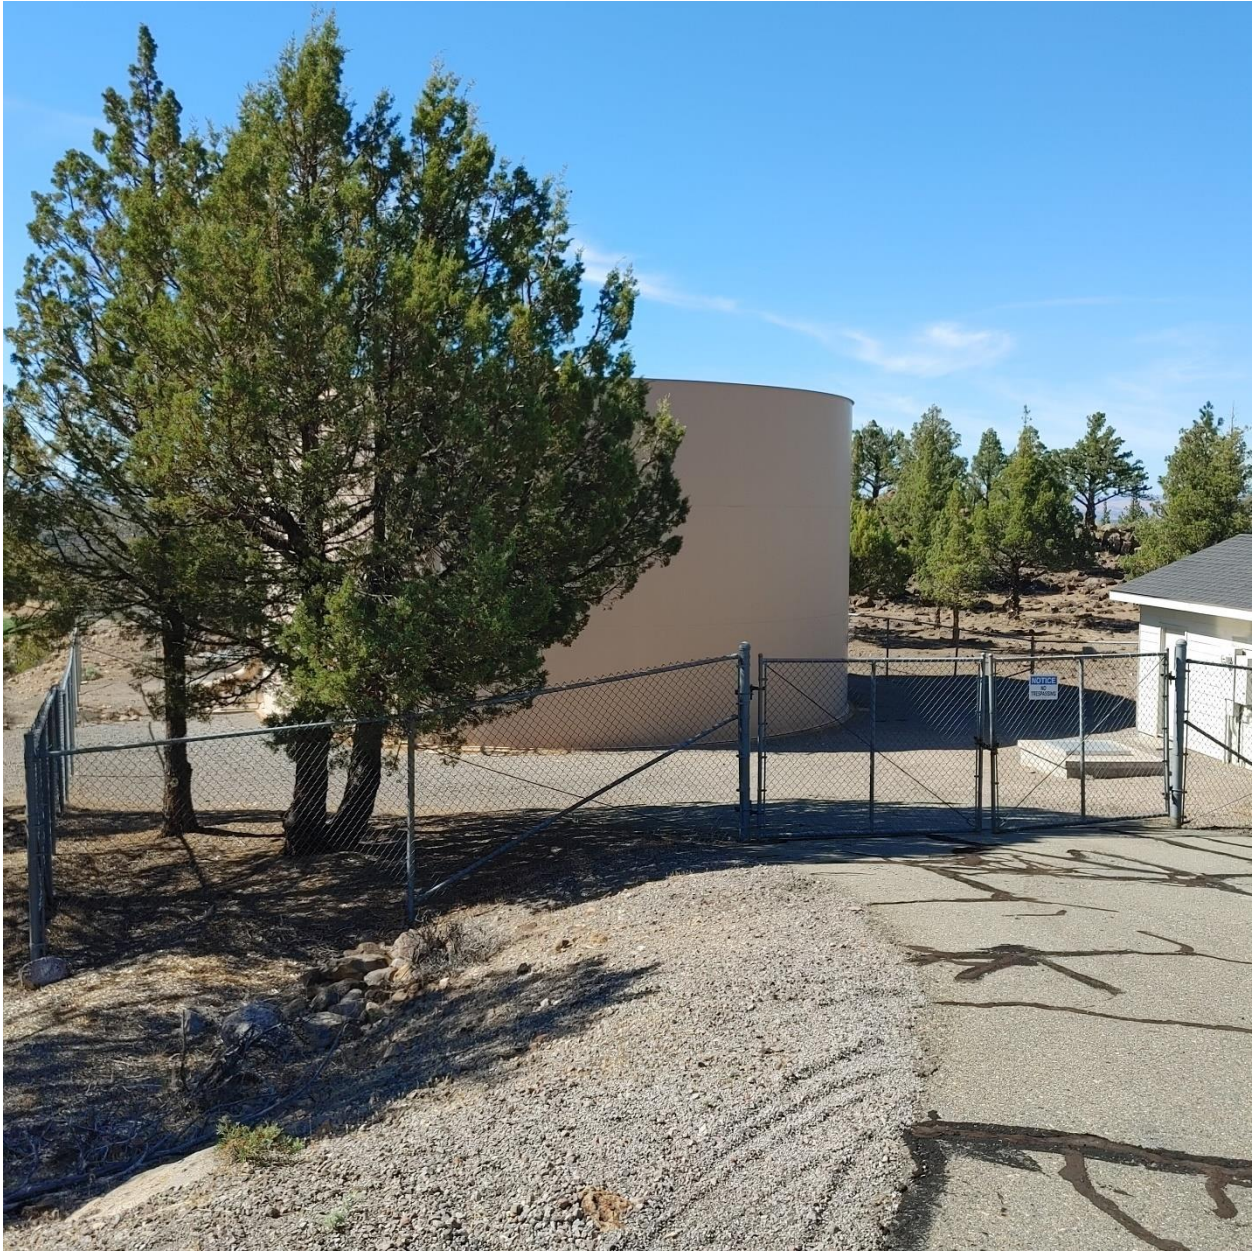
Photo 3: Looking north west from Stone Crest Drive at water tank #3 which is surrounded by small rocks, gravel, and juniper trees. Water tank #3 will be re-painted. Photo taken: 6/22/2022.

- Water tank 4 location APN: 020-071-270-000, LSCSD owned, Dead end of Tennis Court. See Appendix 1, Photo 4.
- Water tank 3 location APN: 108-200-120-000, LSCSD owned, Legal Description: Unit 9-2 Lot 238 Lake Shastina, west side of Stone Crest Drive near the southern dead end. See Appendix 1, Photo 3.

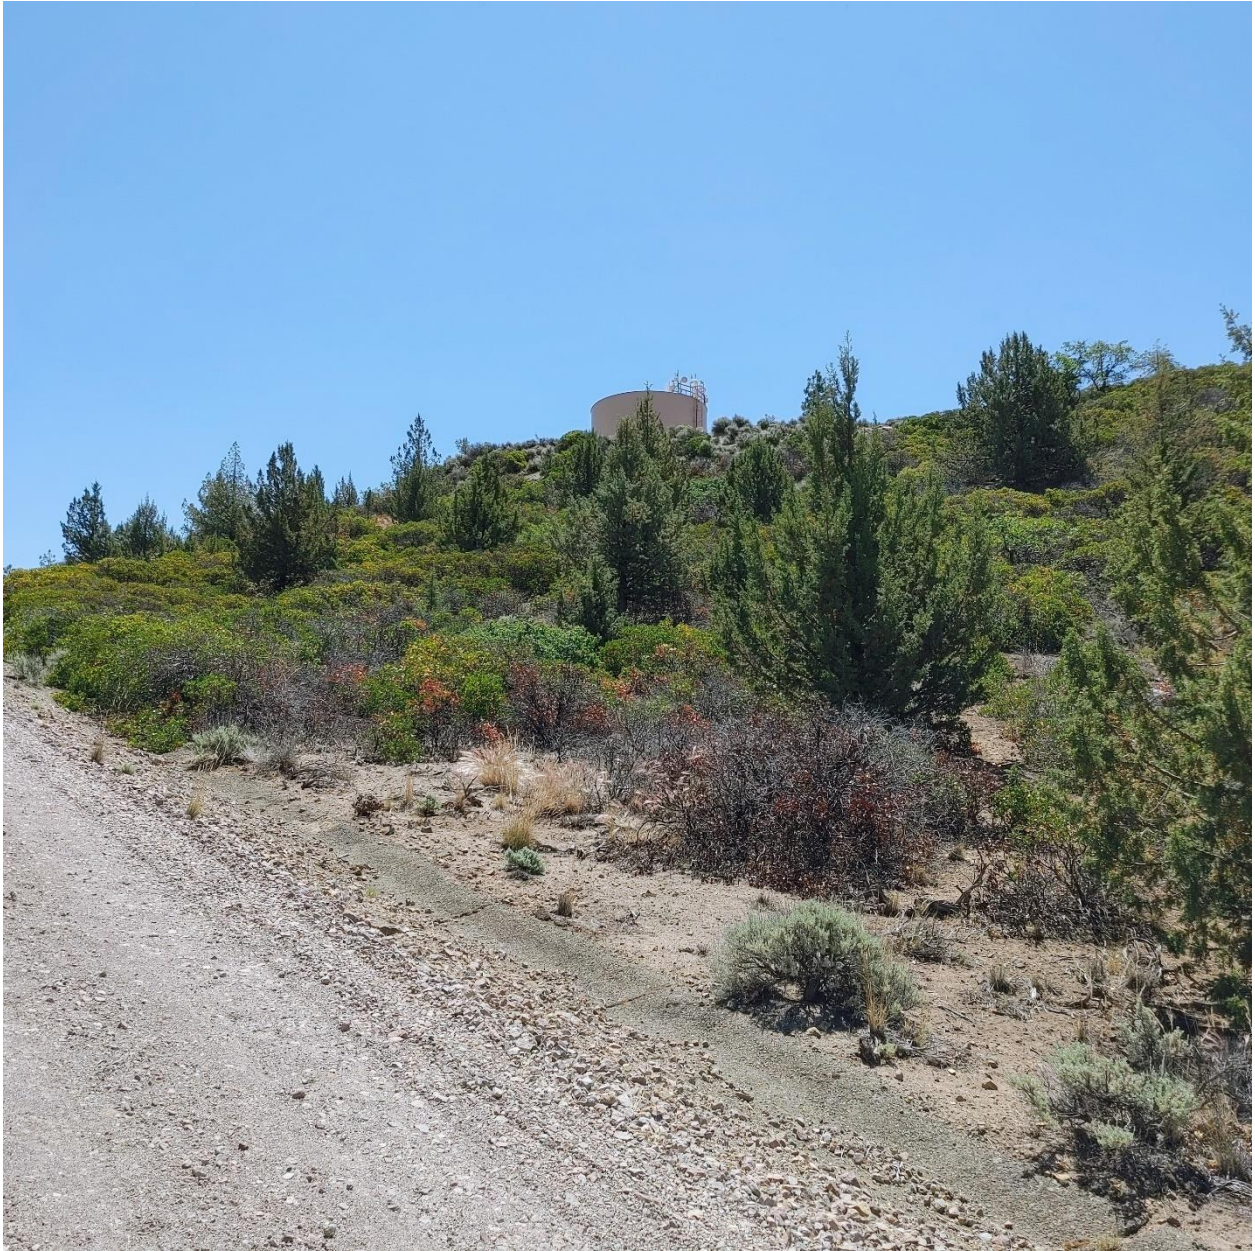
Photo 4: Looking south from the service road to water tank #4 that will be replaced with a larger water tank. Water tank #4 is surrounded by manzanita shrub, gravelly soil, and juniper.

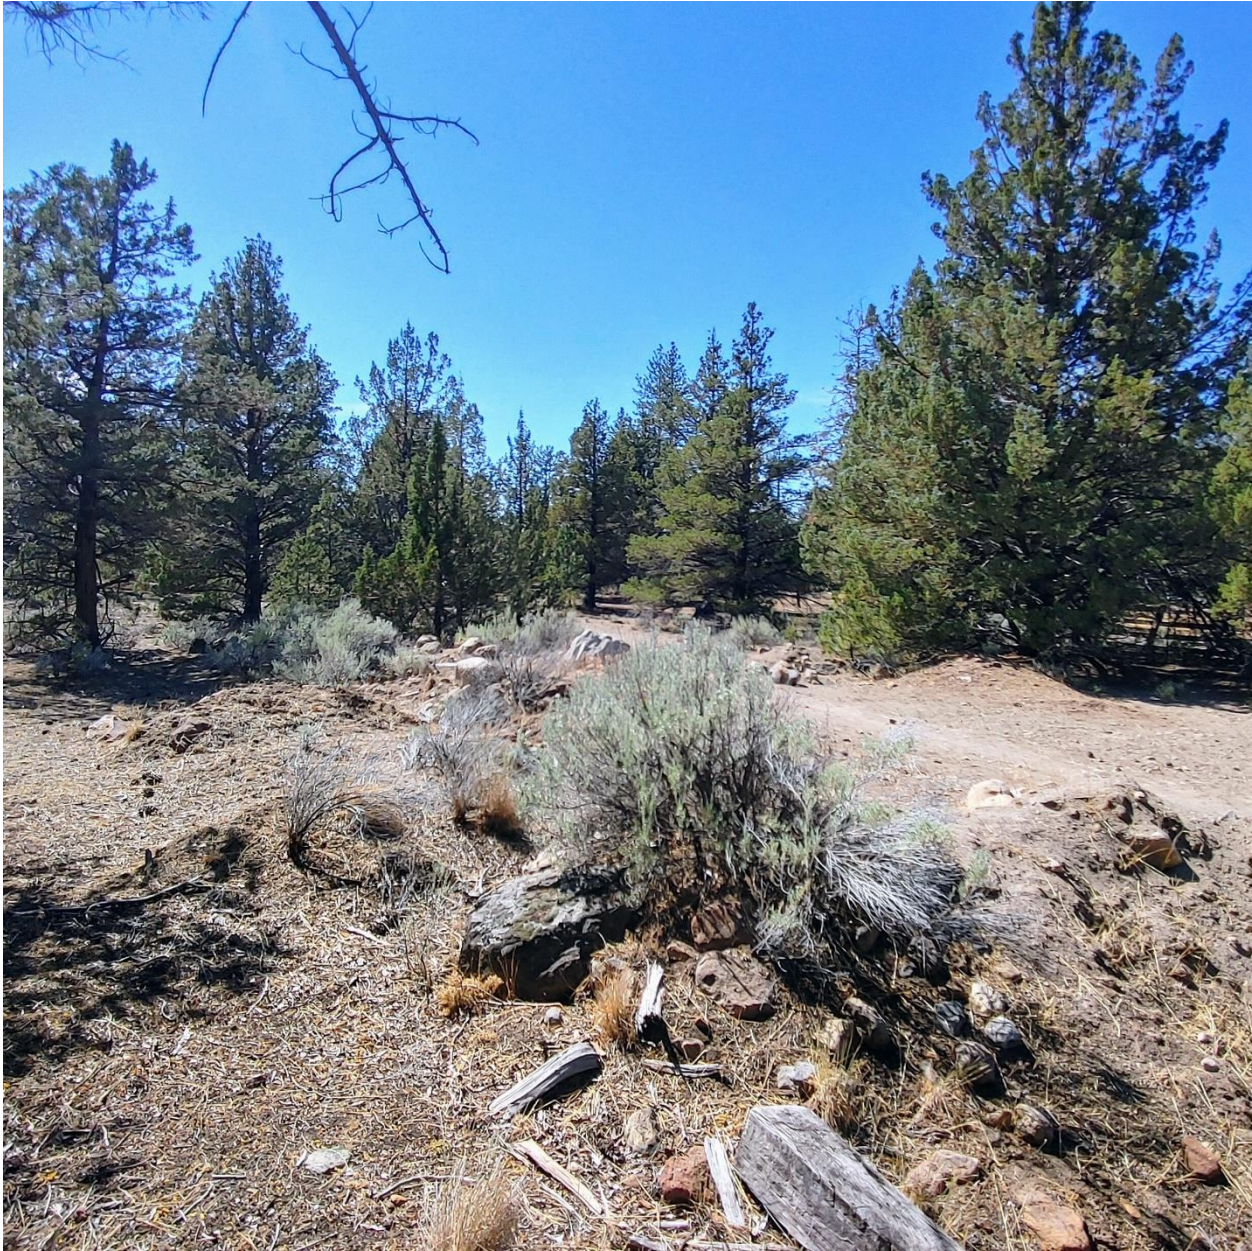
Photo 5: Looking west from the end of Lake Shore Drive where test well #12 would be drilled. Rabbit brush, small rocks, small mounds, and juniper trees can be observed and would be disturbed in the process. No burrows were observed in the mounds and no nests were observed in the trees. Photo taken: 6/22/2022.

- Test Well 12 site location APN: 020-071-430-000, private resident, where Lake Shore Drive and Cottonwood Drive meet up and end. See Appendix 1, Photo 5, and Figure 2.

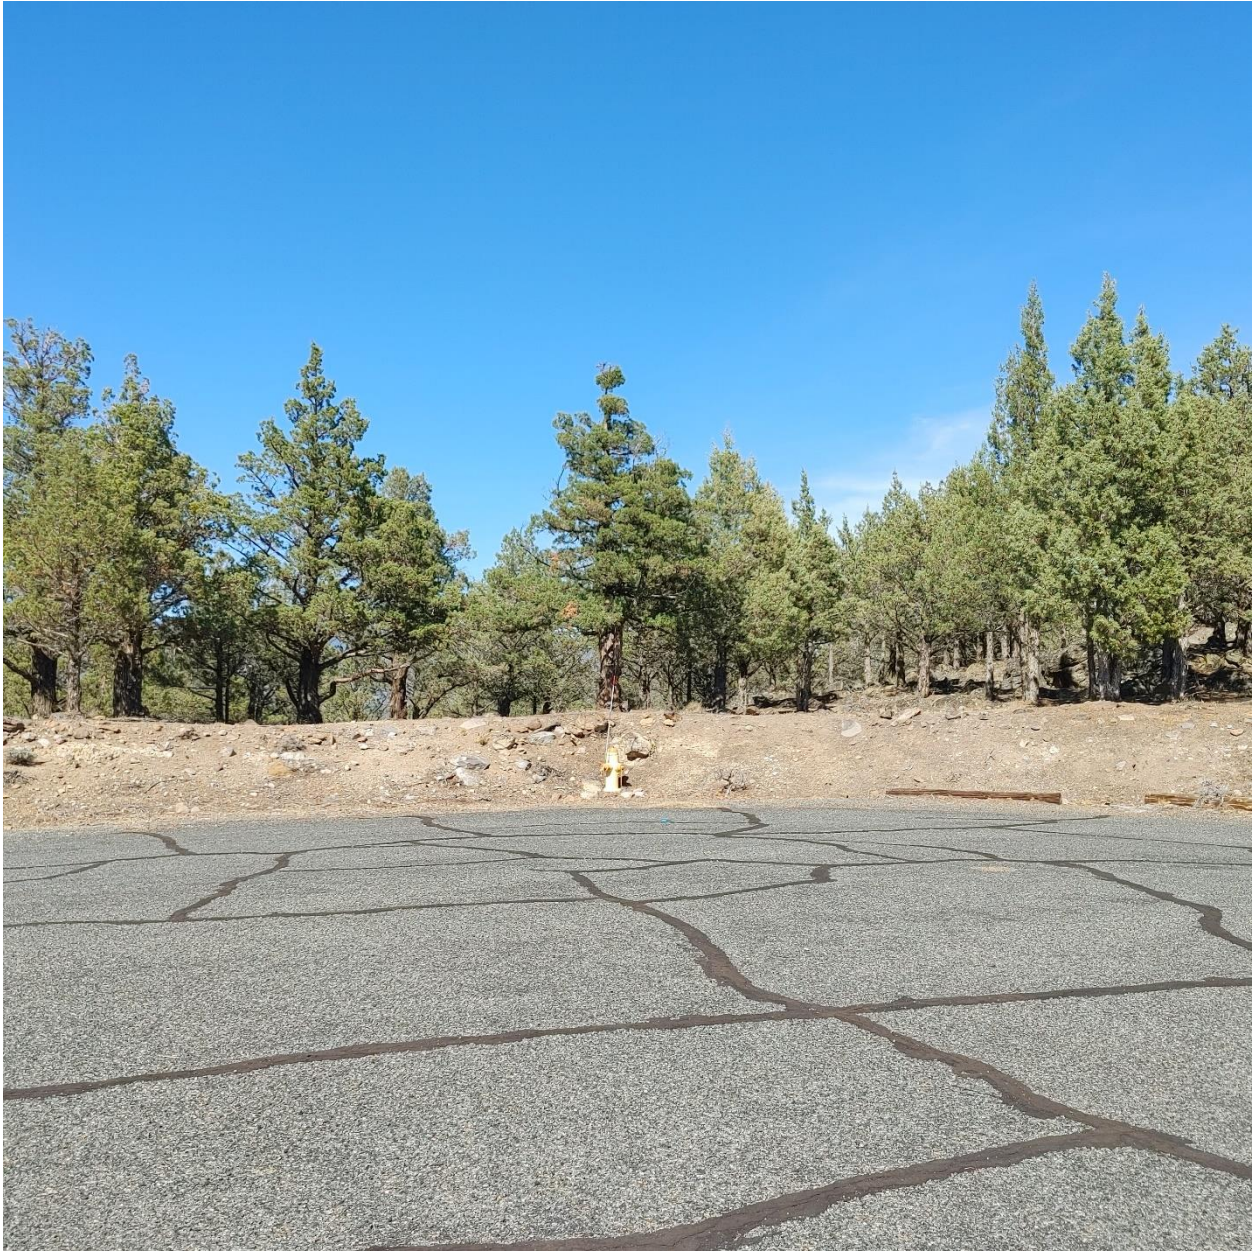
Photo 6: Looking North east from the cul-de-sac of Stone Crest Drive at fire hydrant #289 that will be replaced with a new fire hydrant. This fire hydrant is surrounded by asphalt, small rocks, gravelly soil, and juniper trees. The soil directly around the fire hydrant will be disturbed as all parts of the hydrant will be replaced down to the elbow in the ground.

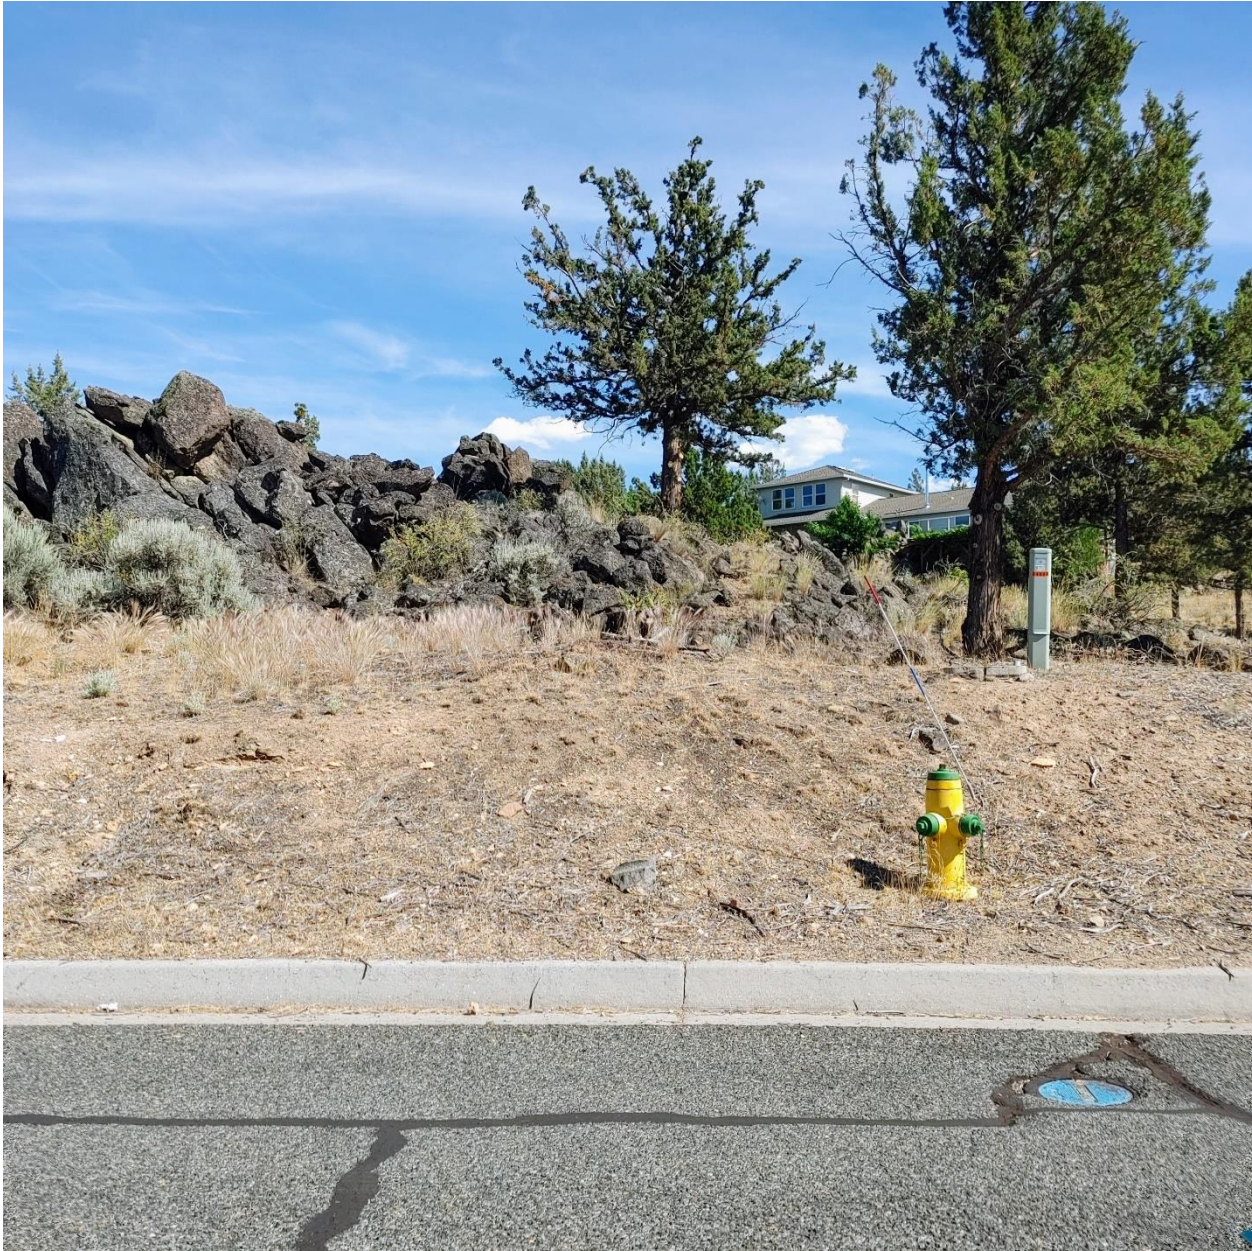
Photo 7: Looking east from Mountain Wood Drive onto fire hydrant #275 that will be replaced with a new fire hydrant. This fire hydrant is surrounded by asphalt, large rocks, gravelly soil, and juniper trees. The soil directly around the fire hydrant will be disturbed as all parts of the hydrant will be replaced down to the elbow in the ground.

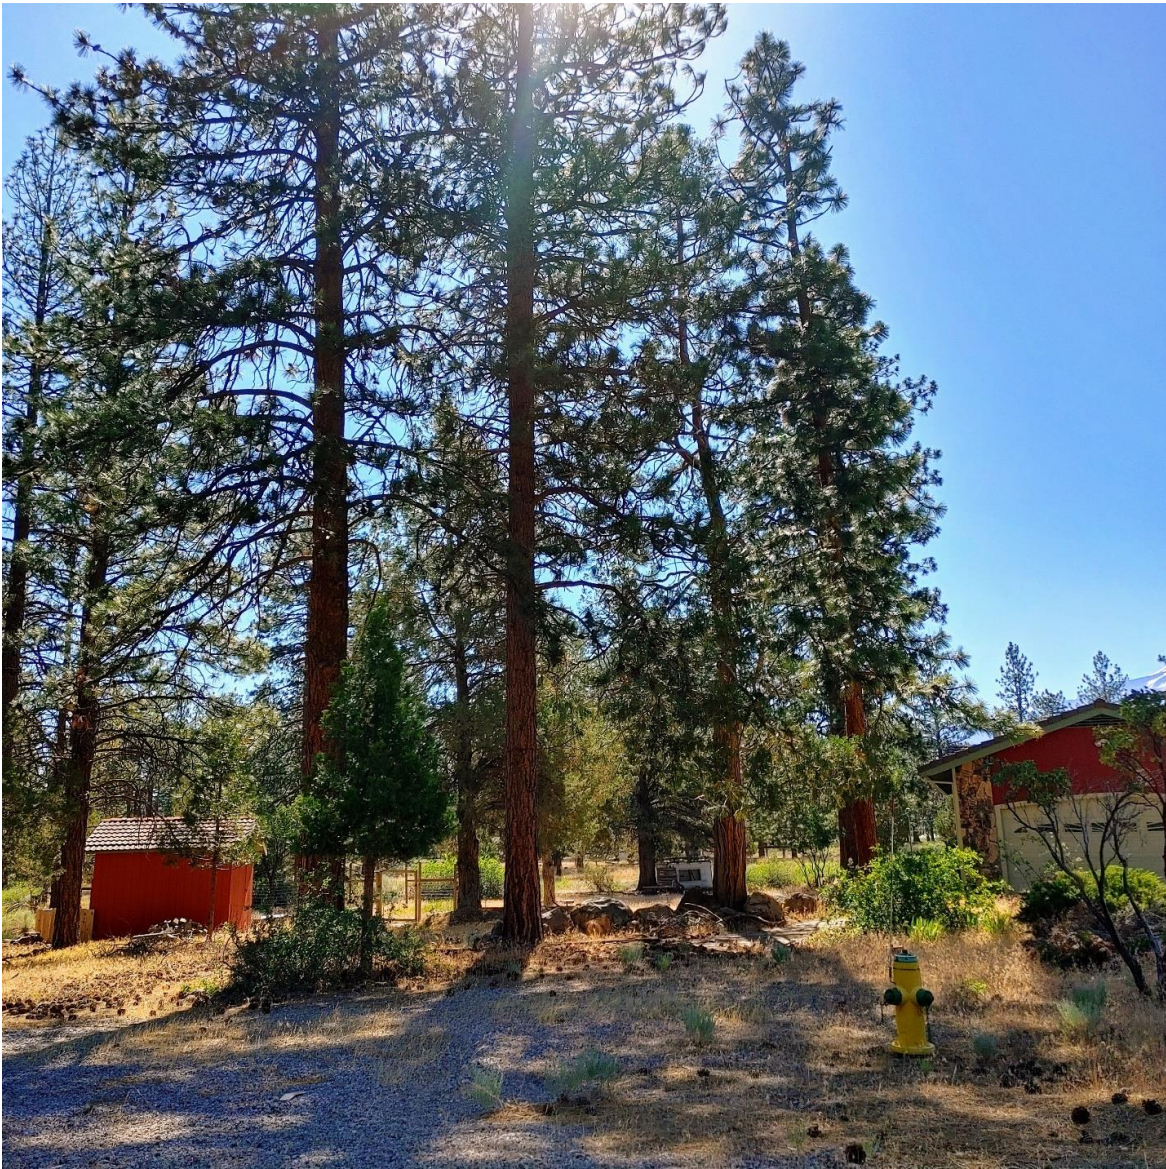
Photo 8: Looking east from Jack Rabbit Road onto fire hydrant #175 that will be replaced with a new fire hydrant. This fire hydrant is surrounded by small rabbit brush, gravelly soil, and ponderosa pine. The soil directly around the fire hydrant will be disturbed as all parts of the hydrant will be replaced down to the elbow in the ground.

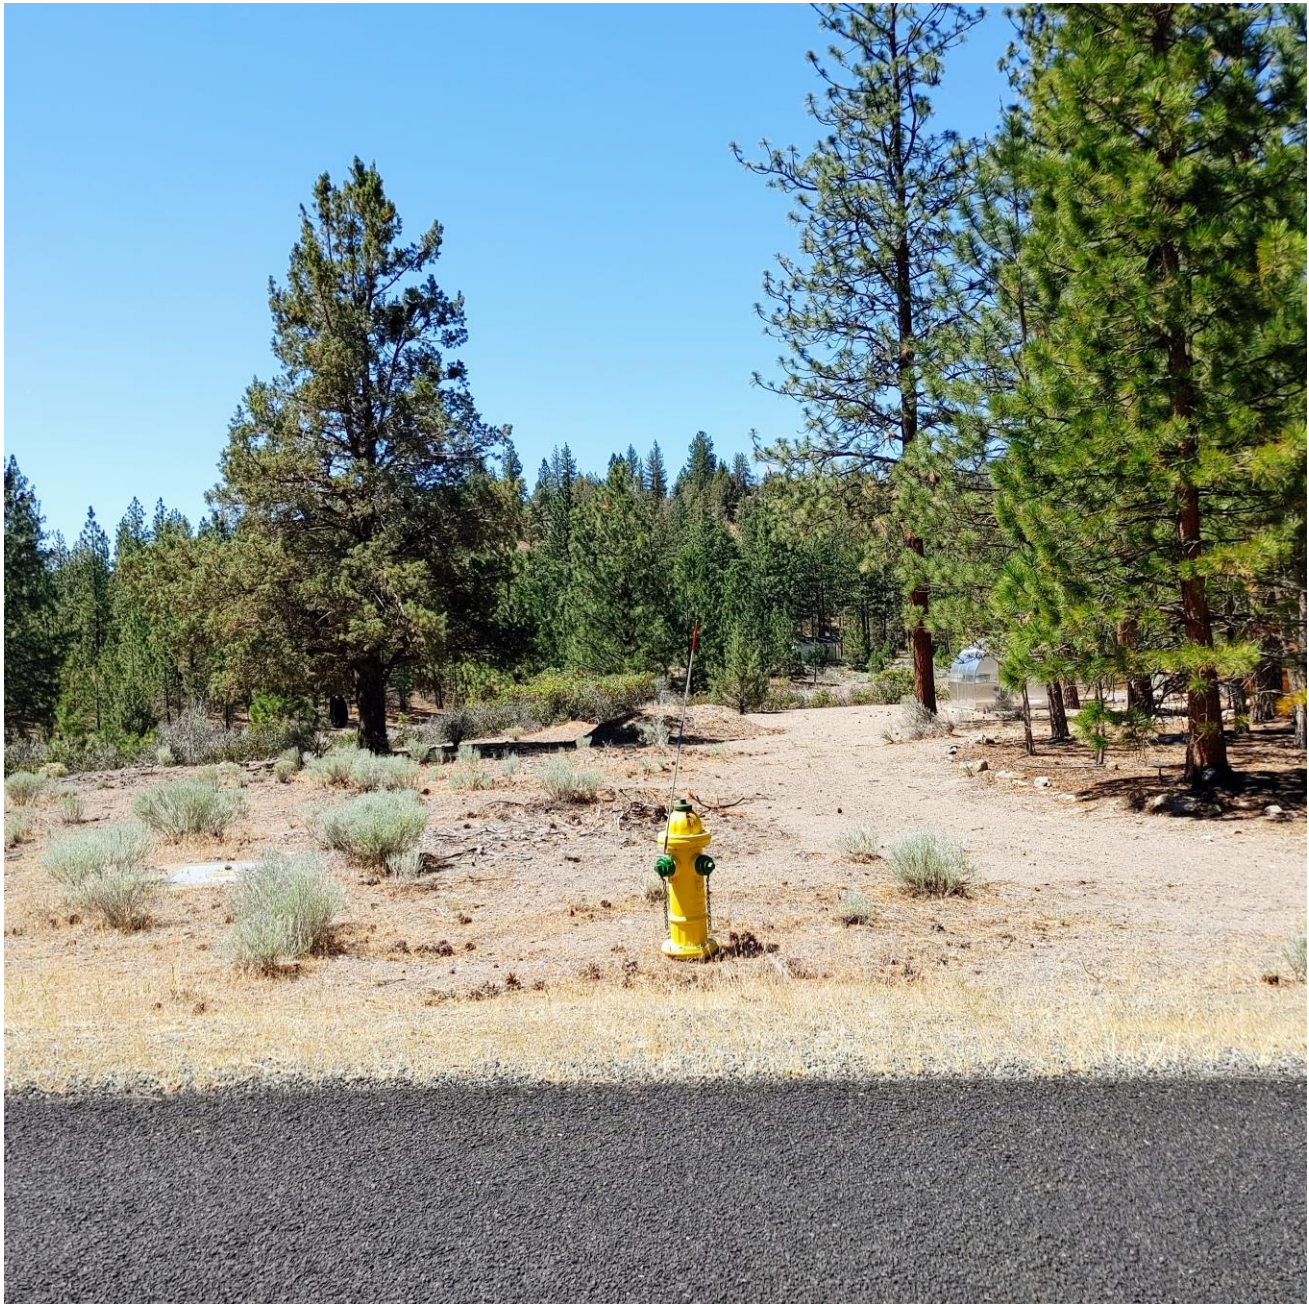
Photo 9: Looking south west from Indian Island onto fire hydrant #79 that will be replaced with a new fire hydrant. This fire hydrant is surrounded by small rabbit brush, gravelly soil, ponderosa pine, and juniper. The soil directly around the fire hydrant will be disturbed as all parts of the hydrant will be replaced down to the elbow in the ground.

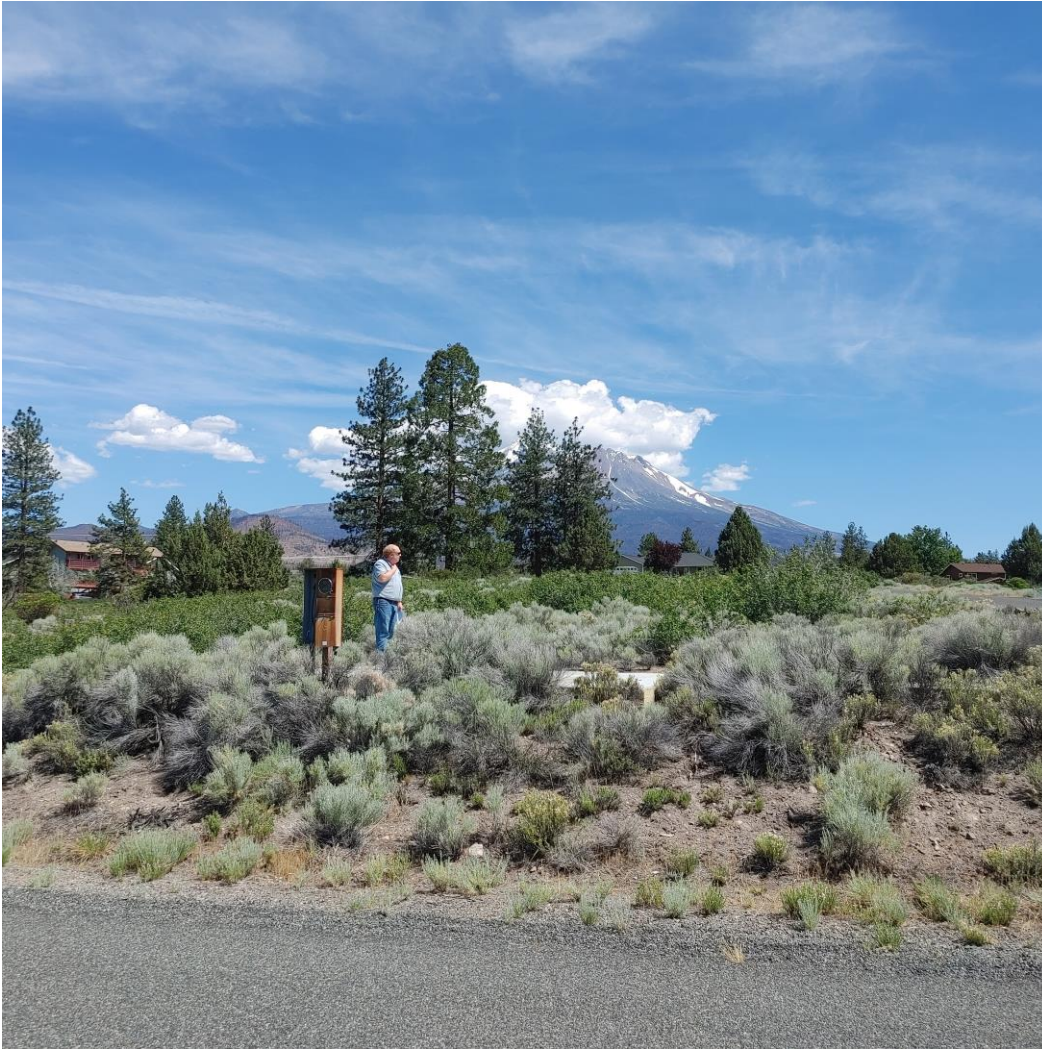
Photo 10: Looking East from Elk Trail Road. Abandoned Pump Station #52 (Figure 3) that is proposed to be a new pump station. The concrete slab that is still present is surrounded by rabbitbrush and manzanita shrub. The soil directly around the concrete will be disturbed when building the pump house. Fire hydrant #190 is the closest to this proposed area (Figure 4).

- New pump station would be placed where the demolished pump station #52 use to be (near fire hydrant 190): APN: 107-450-550-000 (east side of Elk Trail Rd), LSCSD owned, Legal description: Unit 7-2 Incl Por Puma Dr Cottontail Dr Elk Trail & All Fox Ct Lake Shastina See Appendix 2, Photo 10 and Figure 3.
